Protective properties of a multi-layer external coating applied to underground pipes of ductile iron

AGNIESZKA KOCHMAŃSKA, ANNA WASSILKOWSKA, WOJCIECH DĄBROWSKI

DOI 10.36119/15.2020.8.5

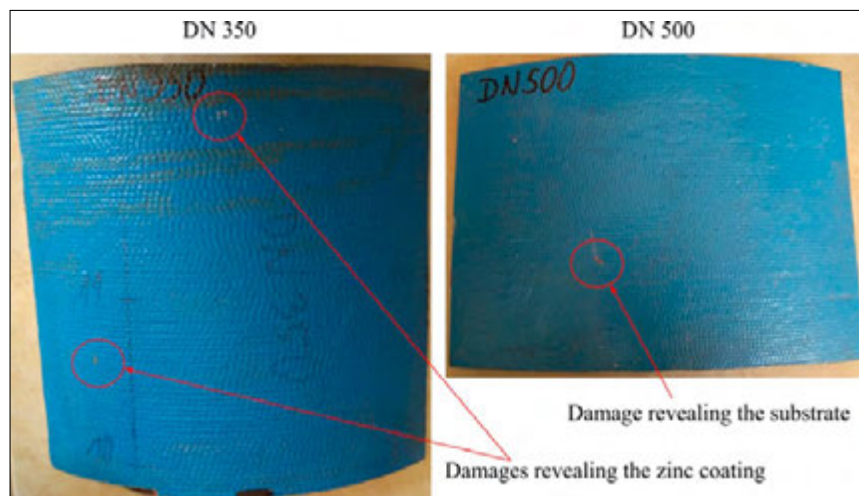
samples were visually examined for potential damages in the coating (Fig. 2).

Fig. 2.
Images of the material cut from the pipes with diameter of 350 mm and 500 mm
Ryc. 2. Zdjęcia materiału wyciętego z rur o średnicy 350 mm i 500 mm

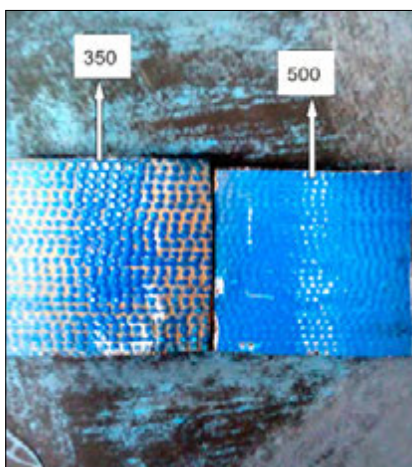
Fig. 3.
Images of samples abrasion using paper of 1000#. Blue sediment for the pipe DN 350 and gray sediment for DN 500, respectively.
Ryc. 3. Widok próbek ścieranych na papierze o gradacji 1000#. Niebieski osad dla rury DN 350 i szary osad odpowiednio dla rury DN 500.

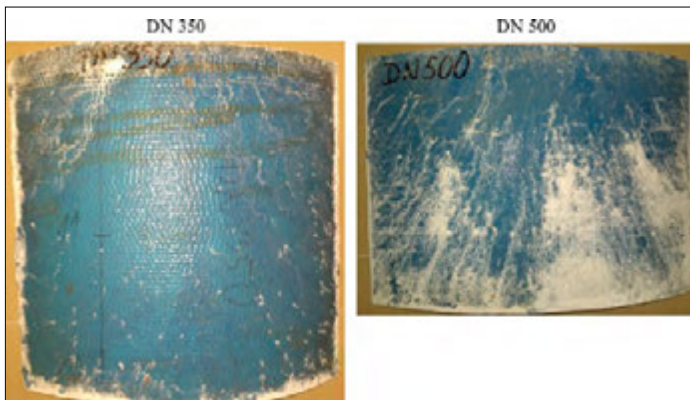
The photographs of the samples after the salt spray test are presented in Fig. 5. After 100 hours of the test three areas with red corrosion (corrosion products of cast iron substrate) were noticed on the pipe sample DN 350. Two of these spots matched the damages observed before the test. The areas with red corrosion spots did not increase throughout the test. The first symptom of white corrosion (the corrosion product of the metallic coating) was spotted only at one point (at the upper edge) after 200 hours of the test. Except this single point, no other changes related to the corrosion of the zinc coating were noticed for next 700 hours of the test. After 1000 hours in the salt chamber, the sample DN 350 looked much better than the sample from the pipe DN500.

In case of the sample DN 500, the first symptoms of white corrosion were observed after 100 hours of the test. After this time, two areas with red corrosion were found; one of them matched the dam-

Fig. 5. The samples after 1000 hours of the salt spray test.
Ryc. 5. Próbkę po 1000 godzinach testu w mgłę solnej.

age of the coating observed before the test. After each subsequent stage of the test, the other areas with corrosion products of the metallic coating (white corrosion) were observed. It proves a low quality of the paint coating.

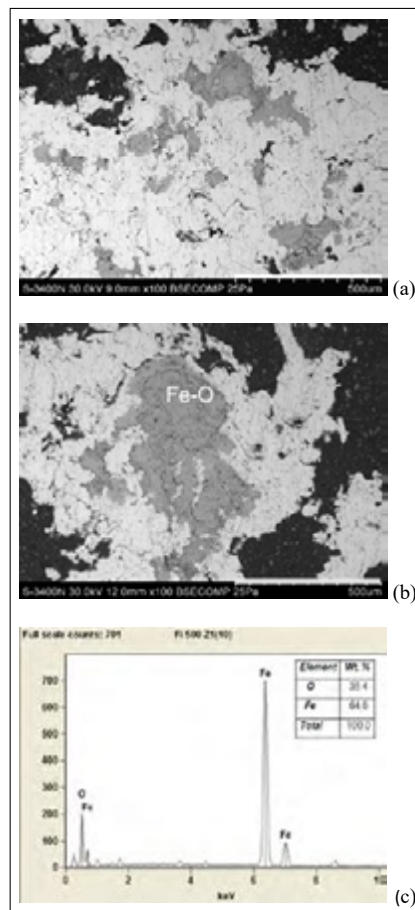
Fig. 6. Microstructure observed on flat spot-sections using the SEM microscope: a, b) two different "spots" of the sample DN500; c) EDS analysis of the ferric oxide area (magnification bar of 0.5 mm)
Ryc. 6. Mikrostruktura zaobserwowana na płaskich przekrojach plamkowych za pomocą mikroskopu SEM: a, b) dwa różne „punkty” próbki DN500; c) Analiza EDS obszaru tlenku żelaza (pasek powiększenia 0,5 mm)

oxides are continuously surrounded by the Zinalium protective layer (Fig. 6 a,b). The EDS analyze indicates that the visible oxide spot contains exclusively iron and oxygen. This means that the uncovered layer of ferric oxides is external, as the lower layer always contains silica in the concentration between 3-7 wt. % [4].

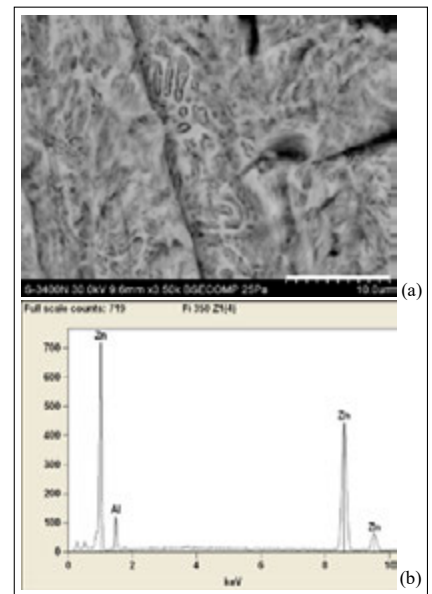
Fig. 7. Microstructure of the Zn-Al coating: a) flat section of the sample DN500 (magnification scale of 10 mm), b) EDS analysis of the coating
Ryc. 7. Mikrostruktura powłoki Zn-Al: a) płaski przekrój próbki DN500 (skala powiększenia 10 mm), b) Analiza powłoki EDS

In Figure 7 a fragment of Zn-Al alloy is presented and zinc and aluminium grains can be easily recognized. As it is known, this alloy contains micro-pores created during thermal spraying. According to [9], the pores size is in the range of 2.5 to 10 µm. The zinc coating mass cannot be calculated from the cross section of a pipe wall because of the pores, as presented in Figure 7. Other electrolytical methods can be applied for this purpose. The coating consists of lamellas of the thickness from 10 to 15 micrometers (Fig. 7).

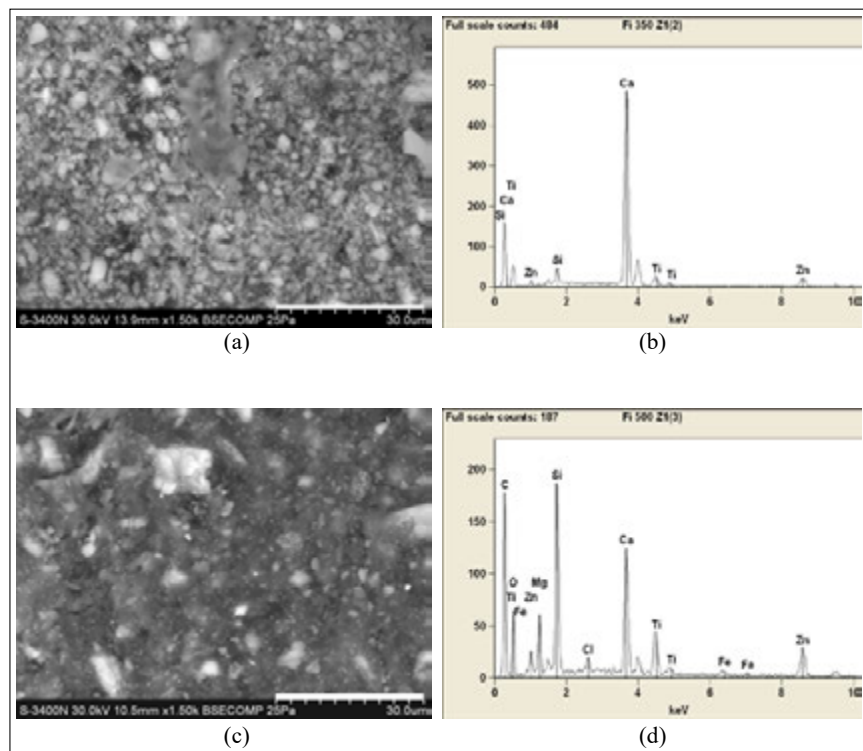
The EDS analysis of two paint coatings applied by two producers to protect the pipes DN 350 and DN 500 are presented in Fig. 8. The paint (A) that gives much better protection to the Zinalium coating contains high concentrations of Ca and Zn, as presented in Table 3 and in the form of X-ray peaks (Fig. 8b).

The EDS analyze does not apply to the five elements of the lowest number of protons and usually overestimates the carbon concentration (Tab. 3). The composition of the less protective paint (B) is significantly different. The paint comprises mostly carbon and traces of other elements: Si, Zn, Ti and Mg.

Fig. 8. Paints morphology and a chemical composition: a) the sample DN 350, b) the respective EDS analysis, c) the sample DN500, d) the respective EDS analysis (magnification scale of 30 mm)
Ryc. 8. Morfologia farb i skład chemiczny: a) próbka DN 350, b) odpowiednia analiza EDS, c) próbka DN500, d) odpowiednia analiza EDS (skala powiększenia 30 mm)
