Protective properties of a multi-layer external coating applied to underground pipes of ductile iron

AGNIESZKA KOCHMAŃSKA, ANNA WASSILKOWSKA, WOJCIECH DĄBROWSKI

DOI 10.36119/15.2020.8.5

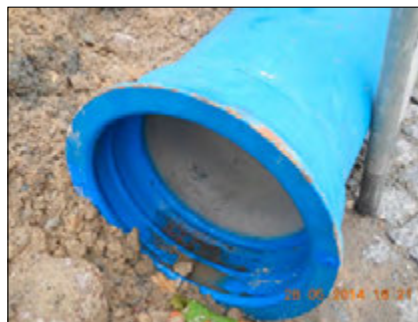
Fig. 1.
Standard water pipe before using in a municipal pipeline. View from the socket
Ryc. 1. Standardowa rura wodociągowa przed montażem do rurociągu miejskiego. Widok od strony kielicha

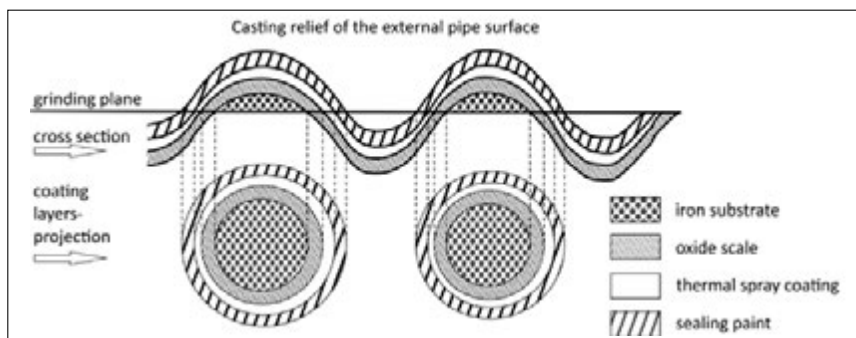
Fig. 4.
Diagram of the grinding plane tangential to the external pipe surface - theoretical appearance of flat "spots" for a further metallographic study has been shown.
Ryc. 4. Schemat płaszczyzny szlifowania stycznej do powierzchni zewnętrznej rury - pokazano teoretyczny wygląd płaskich „plam” do dalszych badań metalograficznych.

representative flat section image of a Zn-Al coating was strongly diffused and did not comply with the theoretical considerations undertaken in Fig. 4; it means an irregular thickness of the protective coating, as described by [8]. A thickness of a thermal diffusion zinc coating is not homogeneous, which can be seen in Fig. 7, presenting a photograph of a pipe wall cross-section. In spite of this, it can be seen that ferric
